**Object:** Fire Pumper  
**Maker:** Joel Bates  
Philadelphia, PA  
**Date of Manu:** 1838 - 1840  
**Materials:** Oak, ash, tulip poplar, iron, brass  
**Dimensions:** 88" H x 184" L x 66" W

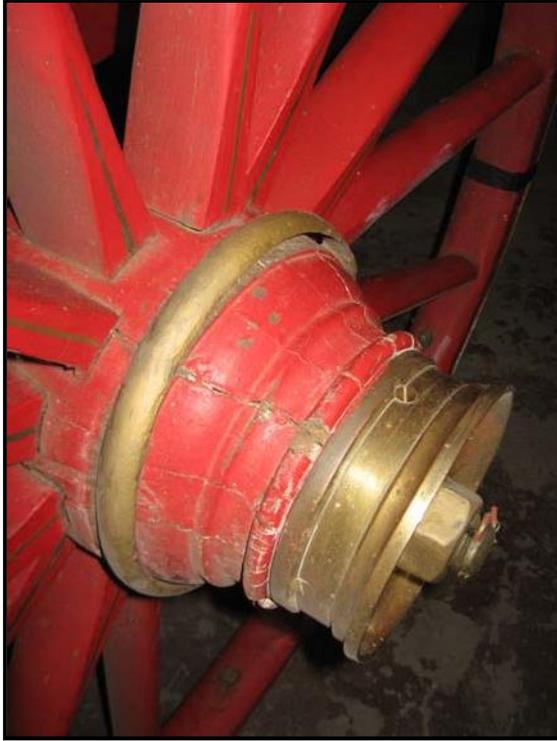
**Proper right rear wheel**

This vehicle is structurally unstable. The wheels are in poor and unstable condition having areas in the felloe which are damaged by fungal decay. The spoke to hub joinery is quite loose and the wheels have significant "play" when side to side pressure is placed upon them. The iron tire is loose on the proper right rear wheel; small splits and fractures are found in the turn wooden wheel hubs.

1. The fire pumper will be vacuumed, brushed, and surface cleaned in order to reduce filth and grime.
2. A penetrating consolidant, such as polyvinyl butyrol will be applied to areas of decayed wood. To help to strengthen those weakened sections.
3. Unstable joinery, cracks, and splits will be stabilized and filled where necessary with an appropriate material.
4. If necessary, the proper right rear wheel will be replicated, using all original components where possible.
5. Replicate the rear outer cast brass hub nut covers and replace the non original front hub bands

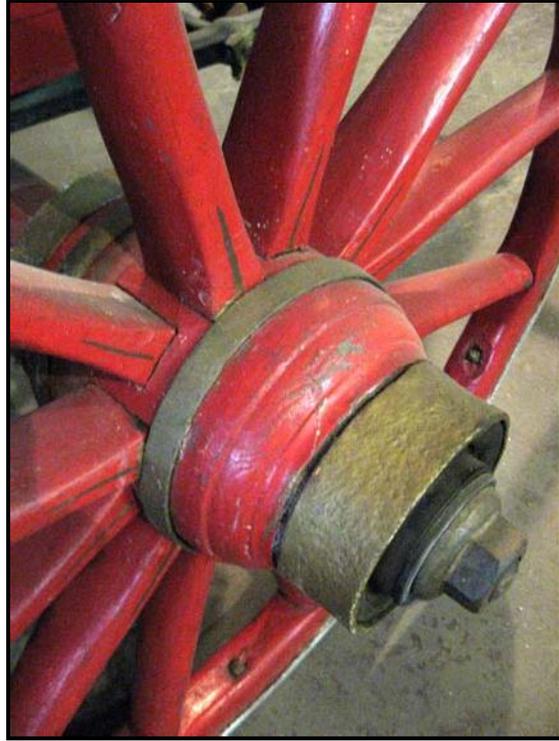
**Proper left front wheel**

The front hubs are not matched to the rear wheel hubs and the front iron tires are significantly more worn than those on the rear; therefore, it is believed that the front wheels were replaced.

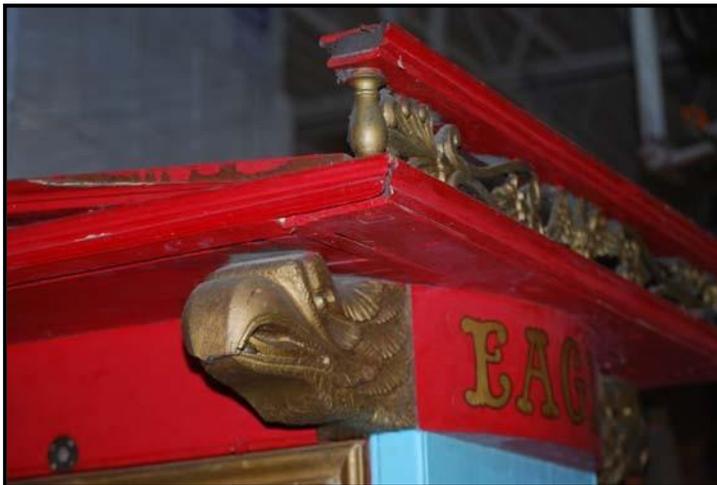
**Damaged super-structure balustrade**

There are numerous wooden components which are loose, detached, or split: the upper gallery/balustrade is loose and several sections of wooden moldings are split on the front, proper right corner; the proper left lower stile is partially detached.

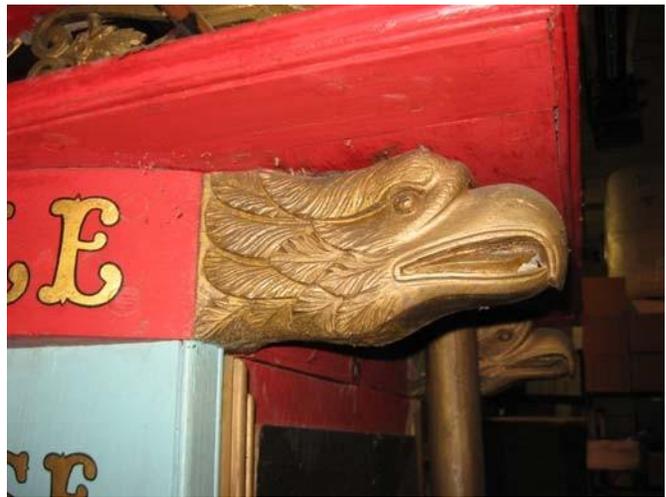
**Re-carved or replaced carved decoration**

The pumper has been partially re-built after, reportedly having been recovered from the Delaware River, in the early part of the twentieth century. The metal components and body are believed to be the only original components which remain, based upon preliminary examinations. The superstructure, which covers the primary pump, also appears to be re-constructed. The balustrade was reconstructed using the original cast brass decorative elements.

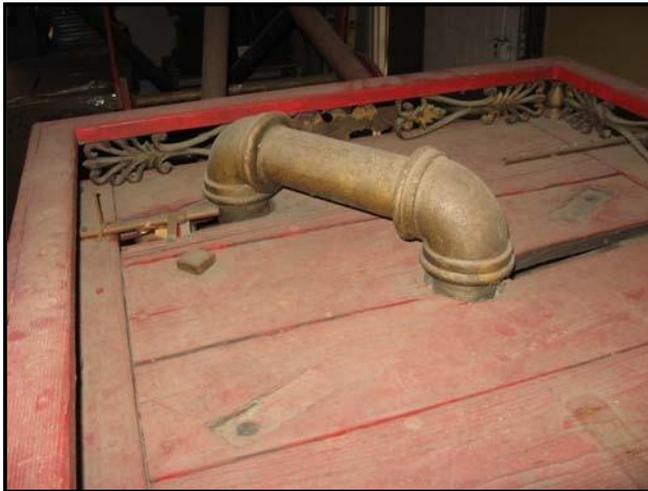
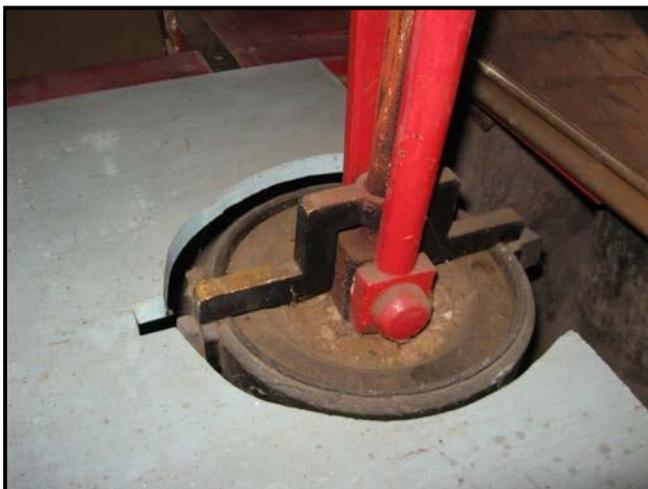
The upper hose nozzle has been modified having a down pipe added to attach to a hose connection secured to the proper right side of the body, just forward of the rear wheel.

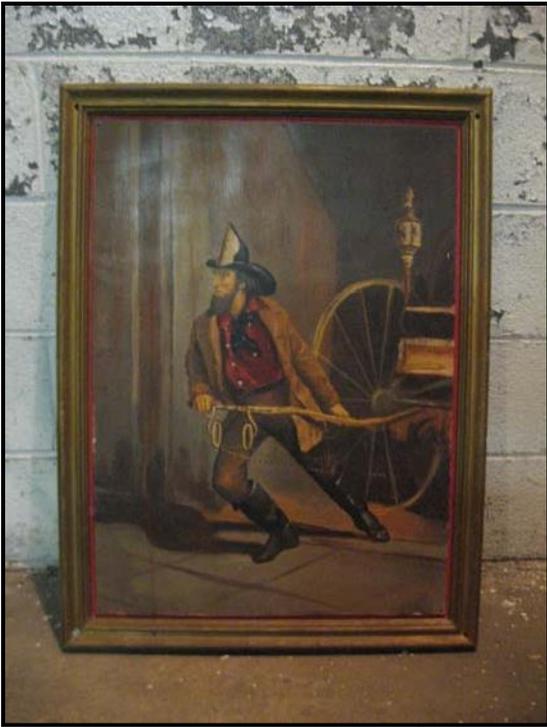
**Front panel with painting**

The painted panels, depicting the two firefighters, were added in the in the 1970's; the paintings are painted on artist board and nailed to the replacement front and rear super-structure panels. Note these panels are made from 3/4" plywood.

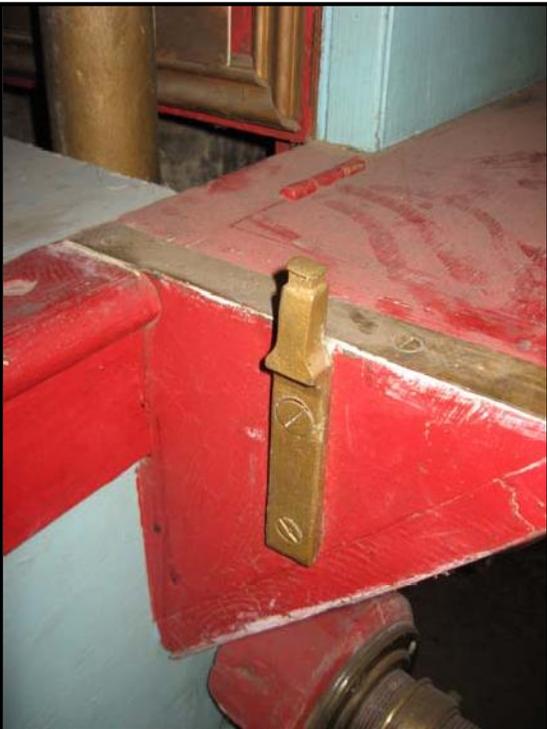
**Broken nozzle "cradle"**

Several of the metal fittings which hold or secure the secondary pump handles and hoses, when the pumper is being moved are broken, bent or missing. Most have been painted with bronze powder paint.

8. Degrease the polished brass components and apply a protective lacquer coating.
9. Replicate the fractured and/or missing metal fittings using the remaining originals as patterns, using sand casting methods.

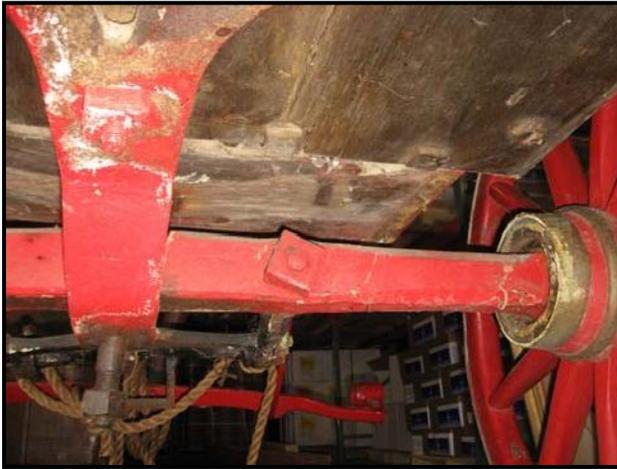
**Underside of front axle**

All metal components have minor areas of active corrosion, including the copper pressure tank.

6. Mechanically and/ chemically stabilize areas of active corrosion.
7. Remove bronze powder paint from cast brass fittings and lightly polish the brass using a cotton wadding polish.
