**Object:** Fire Pumper  
**Maker:** Joel Bates  
Philadelphia, PA  
**Date of Manu:** 1838 - 1840  
**Materials:** Oak, ash, tulip poplar, iron, brass  
**Dimensions:** 88" H x 184" L x 66" W

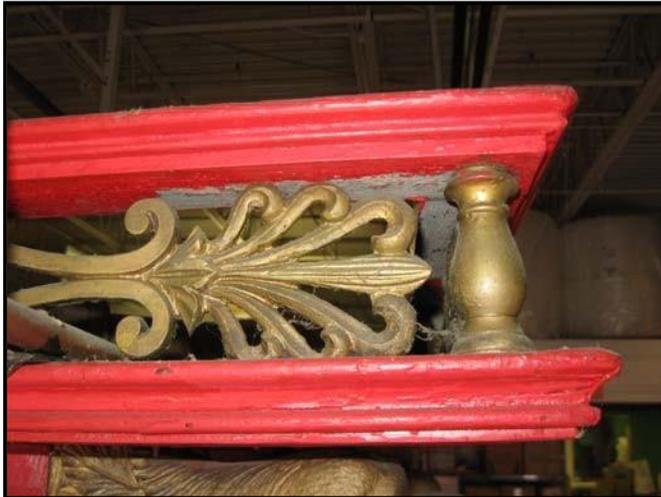
**Brass ornament**

The pumper has been partially re-built after, reportedly having been recovered from the Delaware River, in the early part of the twentieth century. The metal components and body are believed to be the only original components which remain, based upon preliminary examinations. The superstructure, which covers the primary pump, also appears to be re-constructed. The balustrade was reconstructed using the original cast brass decorative elements.

6. Mechanically and/ chemically stabilize areas of active corrosion.
7. Remove bronze powder paint from cast brass fittings and lightly polish the brass using a cotton wadding polish.

8. Degrease the polished brass components and apply a protective lacquer coating.
9. Replicate the fractured and/or missing metal fittings using the remaining originals as patterns, using sand casting methods.

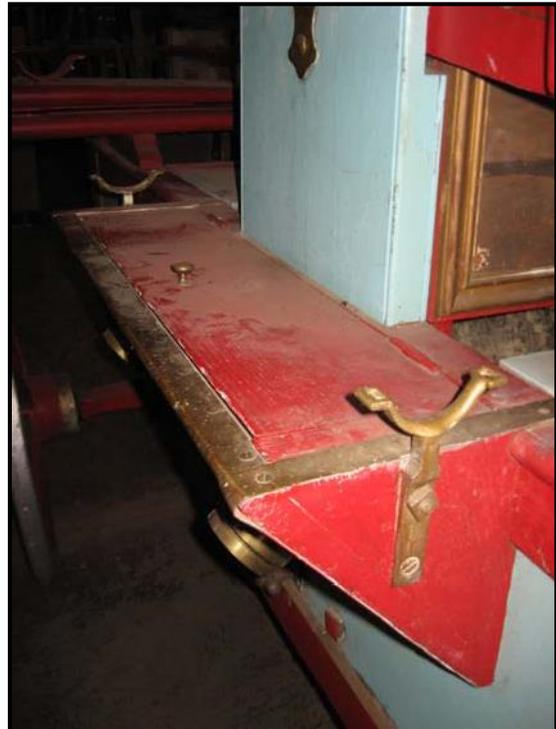
**Intact nozzle "cradle"**

Several of the metal fittings which hold or secure the secondary pump handles and hoses, when the pumper is being moved are broken, bent or missing. Most have been painted with bronze powder paint.
